INDOOR AIR QUALITY REASSESSMENT

**Ralph B. O'Maley Middle School
32 Cherry Street
Gloucester, Massachusetts**

Prepared by:
Massachusetts Department of Public Health
Bureau of Environmental Health Assessment
Emergency Response/Indoor Air Quality Program
December 2003

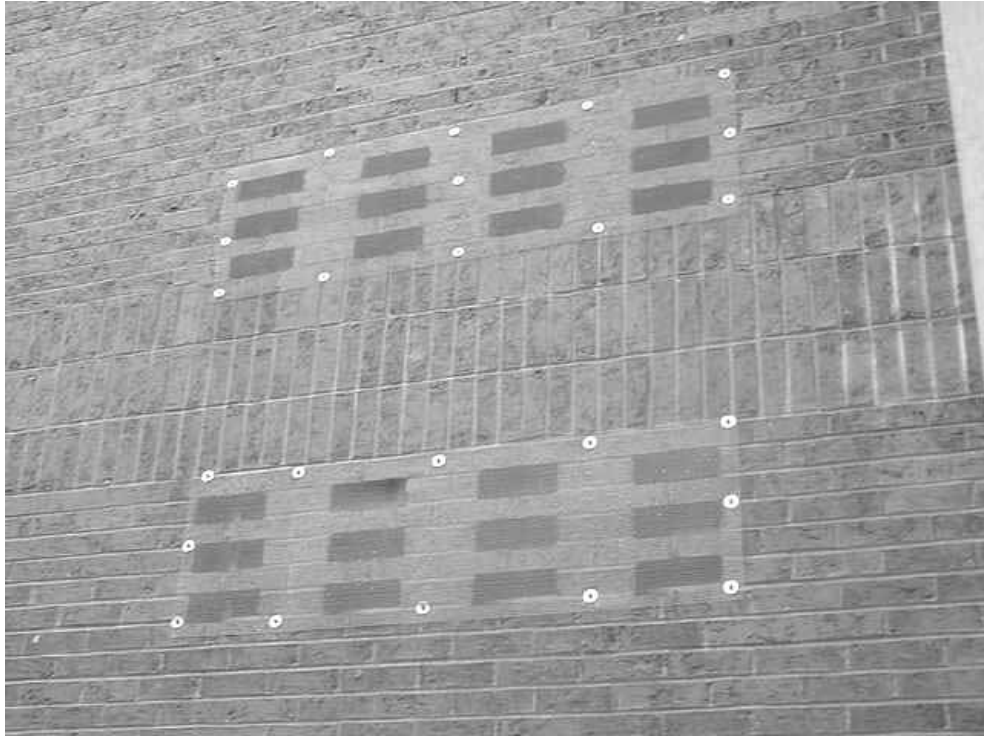
Picture A-1

Bird Screens Installed over Univent Air Intakes

Action Taken: Univents were cleaned and disinfected. Bird screens were installed over openings to prevent bird roosting (Picture A-1).

3. **Clean interior and exterior of univents completely of bird wastes, in accordance with CDC health and safety practices before-reactivating univents. To prevent further bird roosting, consider installing bird screens to the *outside* of brick openings.**

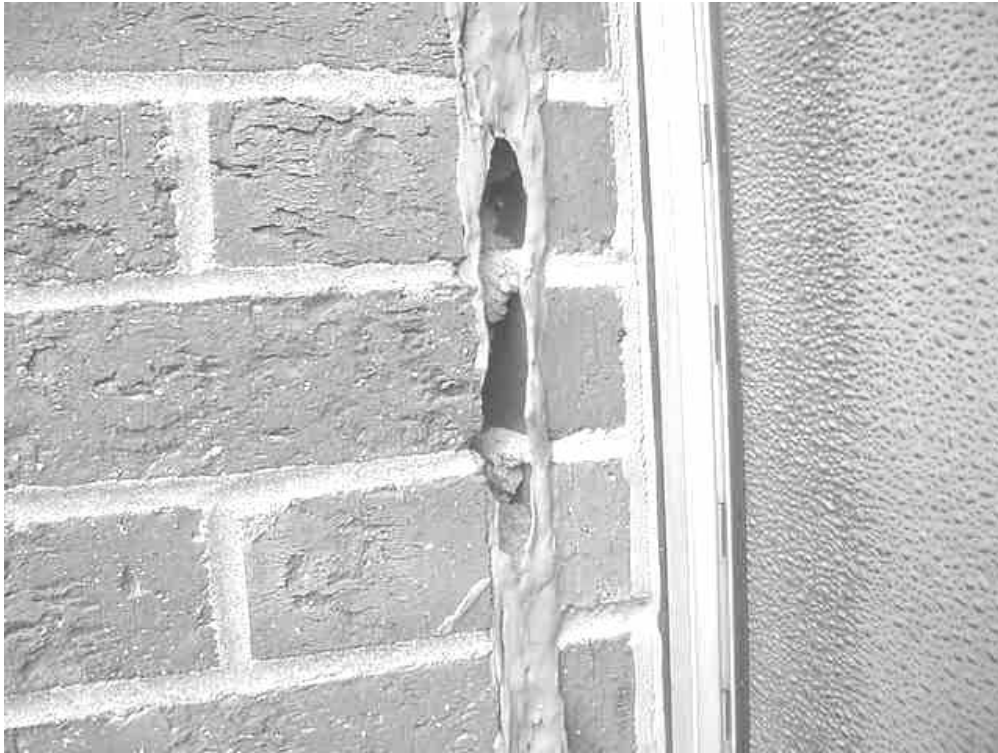
Picture A-2

Unsealed Expansion Joint

Action Taken: Some expansion joints were not resealed during the reassessment (Picture A-2), this activity is reportedly on-going.

- 4. Examine all expansion joint seals on the exterior wall system. Reseal all expansion joints with damaged, missing or eroded sealant.**

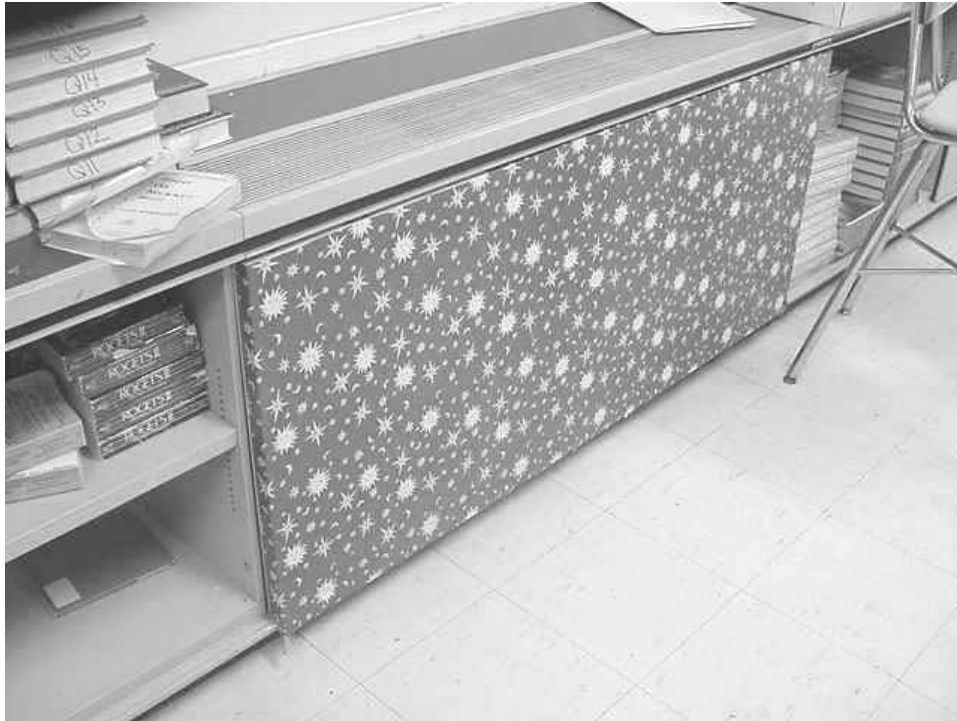
Picture A-3

Univent Return Vent Covered with Fabric Preventing Airflow

Action Taken: Univents and exhaust vents were still obstructed in some classrooms (Pictures A-3 & A-4).

- 8. Remove all blockages from univents and exhaust vents.**

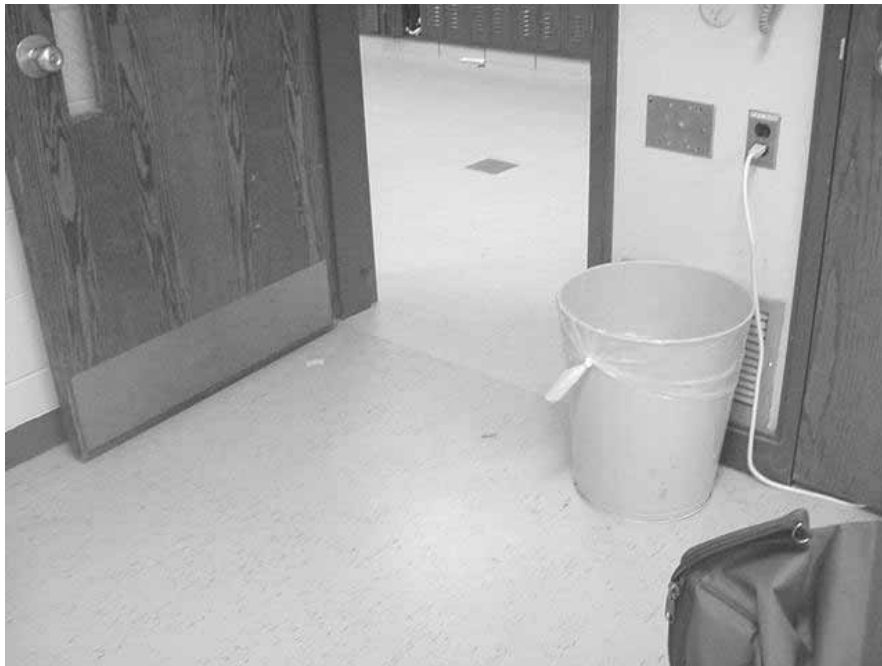
Picture A-4

Exhaust Vent Blocked by Waste Basket

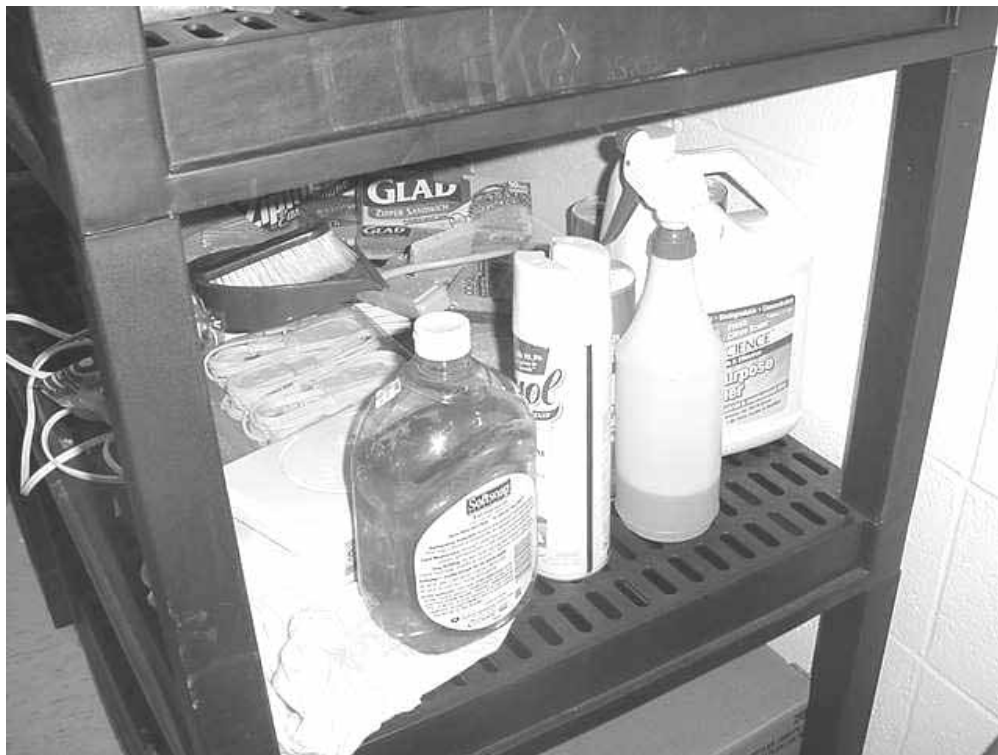
Picture A-5

Commercial Cleaning Products on open Shelf in Classroom

Action Taken: Commercial cleaning products continued to be kept in unlocked cabinets in classrooms (Picture A-5).

- 17. Store cleaning products properly and out of reach of students. Store flammables in a flameproof cabinet.**

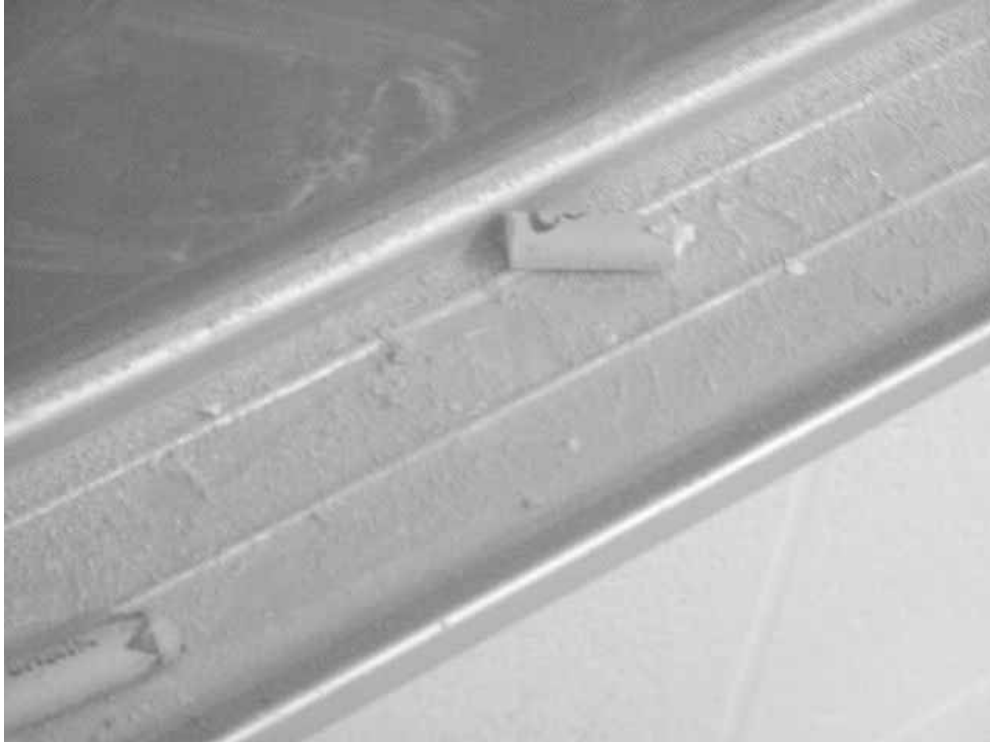
Picture A-6

Accumulated Chalk Dust in Classroom

Action Taken: Several areas continue to have accumulated items and dust/debris accumulation (Picture A-6)

Action Taken: Several classrooms continue to have accumulated chalk dust (Picture A-6)

- 22. Clean chalkboards and trays regularly to avoid the build-up of excessive chalk dust.**

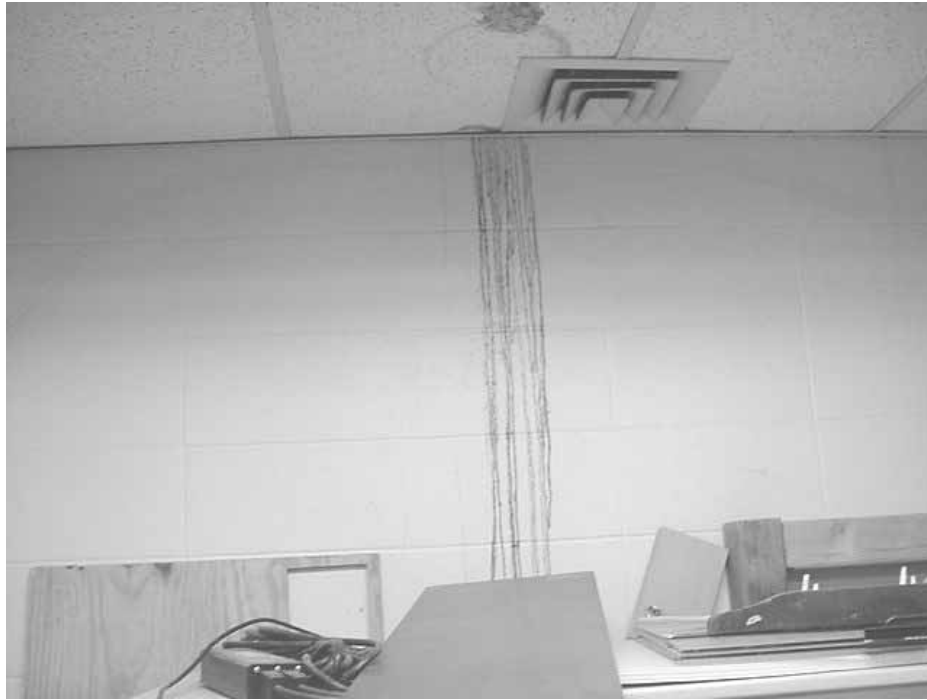
Picture A-7

Roofing Material Stains in 315 Prep-Room

Action Taken: Walls were not cleaned of the dried roofing material during the reassessment (Picture A-7).

- 23. Clean and disinfect walls of the 315 prep room and any other areas coated with dried roofing material.**
